Indentation Scratch Testing with the iMicro

Example - Brittle Thin Film on a Hard Substrate

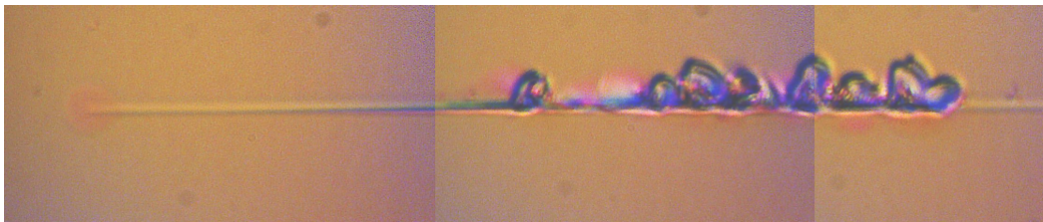
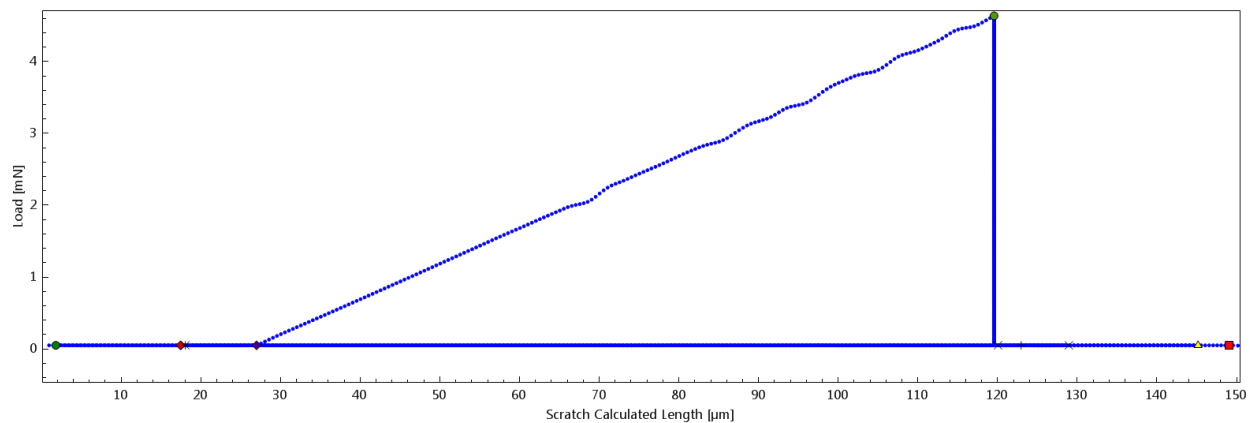
The image below is an example of a scratch performed on a brittle thin film in the iMicro with the InForce1000 actuator. The “Scratch Maximum Load” was 2mN, the “Scratch Length” was 90 microns, and the profiling load was 50 microNewtons. There is clear evidence of the spallation of material in the image as well as excellent correlation to the applied load versus scratch length data.
